Manhole Inspection Summary

Manhole # S21SS1002MH

Location Address: **2 HAMILL RD**

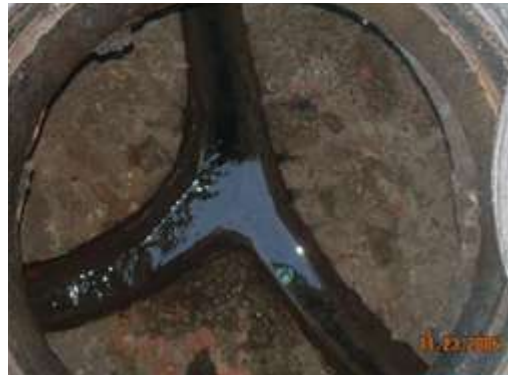
Top View

Evidence of surcharge - Bench debris.

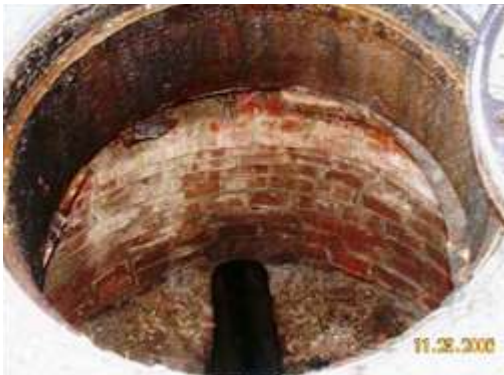
Defect

Frame leaks. Adjustment deterioration and loose brick. Adjustment, Corbel, and Barrel infiltration.

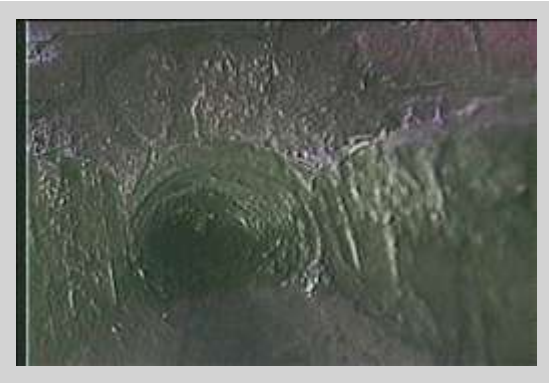
6 in. Circular Gravity Sewer Pipe Out @ 12 O'Clock

Deposits: ☐ None ☐ Mud ☐ Sludge ☒ Debris ☒ Grease

Silt Depth: **0.5** (in.) Deposits Extent: **Light**

Infiltration: **Evidence** Pipe Seal Cond: **Unknown**

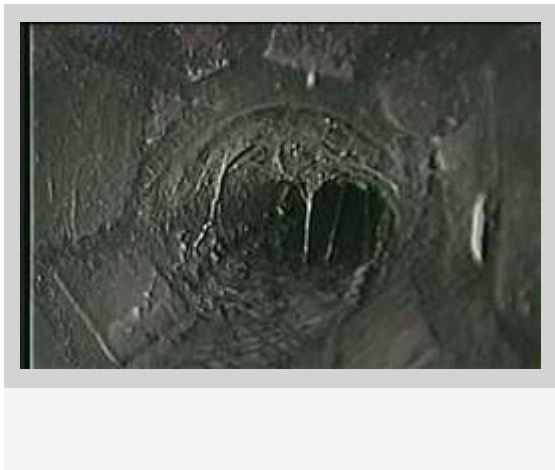
6 in. Circular Gravity Sewer
Pipe In @ 9 O'Clock

Deposits: ☐ None ☐ Mud ☐ Sludge ☐ Debris ☒ **Grease**
